Aspen Fire Tube Boilers

SUBJECT: Aspen Boiler Product Update
TO: Installing Contractors of U.S. Boiler Residential Heating Boilers

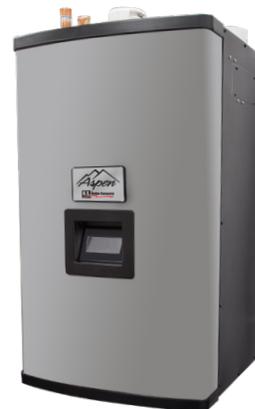
1. Disconnect power from boiler to prevent unit from starting during inspection.
2. Remove black pressure switch sensing hose (see photo A).
3. Insert an unmounted 1/16" inch drill bit into the translucent hose barb to verify there is a hole open to the inside of the vent pipe. If a hole is present, skip to step 5.

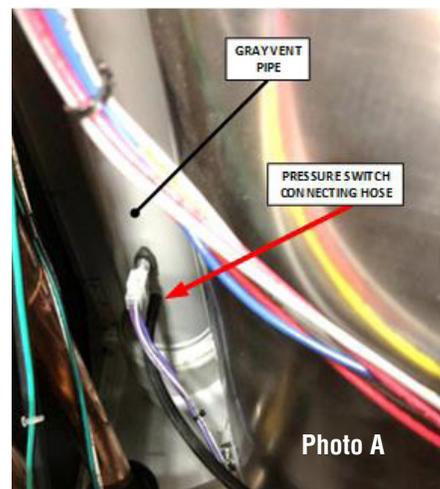
4. If no hole is present, use 1/8" bit and simply drill inside the hose barb to make a hole into the gray plastic vent pipe.
 - 4A. FOR COMBI BOILERS ONLY: If no hole is present, remove the four #2 square head screws holding the control panel mount plate assembly, and tilt the top of the plate outward (Photo B).

- 4B. Route drill under the copper tube, and using a 1/8" bit, simply drill inside the hose barb to make a hole into the gray plastic vent pipe (Photo C).

5. Reconnect the black pressure switch sensing hose.
6. Following the procedures outlined in the Aspen Installation and Operations Manual, restore power to the boiler and verify operation.
